NRL/MR/7440--02-8280

Demonstrating a Moving-Map System With Electronic Charts for Improved Lane Navigation: Testing on AAVs in Gulfport, MS

September 30, 2002

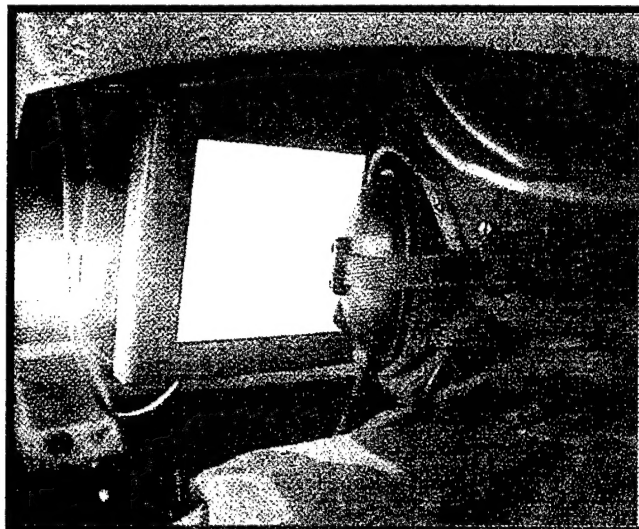
Figure 4. An AAV driver using the MM system during testing in Gulfport, MS.

Figure 4 shows the driver and map display during the actual test in Gulfport. A second, smaller display was installed in the turret for the Crew Chief that showed the same view. PFPS gives the ability to zoom the map display in or out so, it could be adjusted to accommodate viewing preferences.

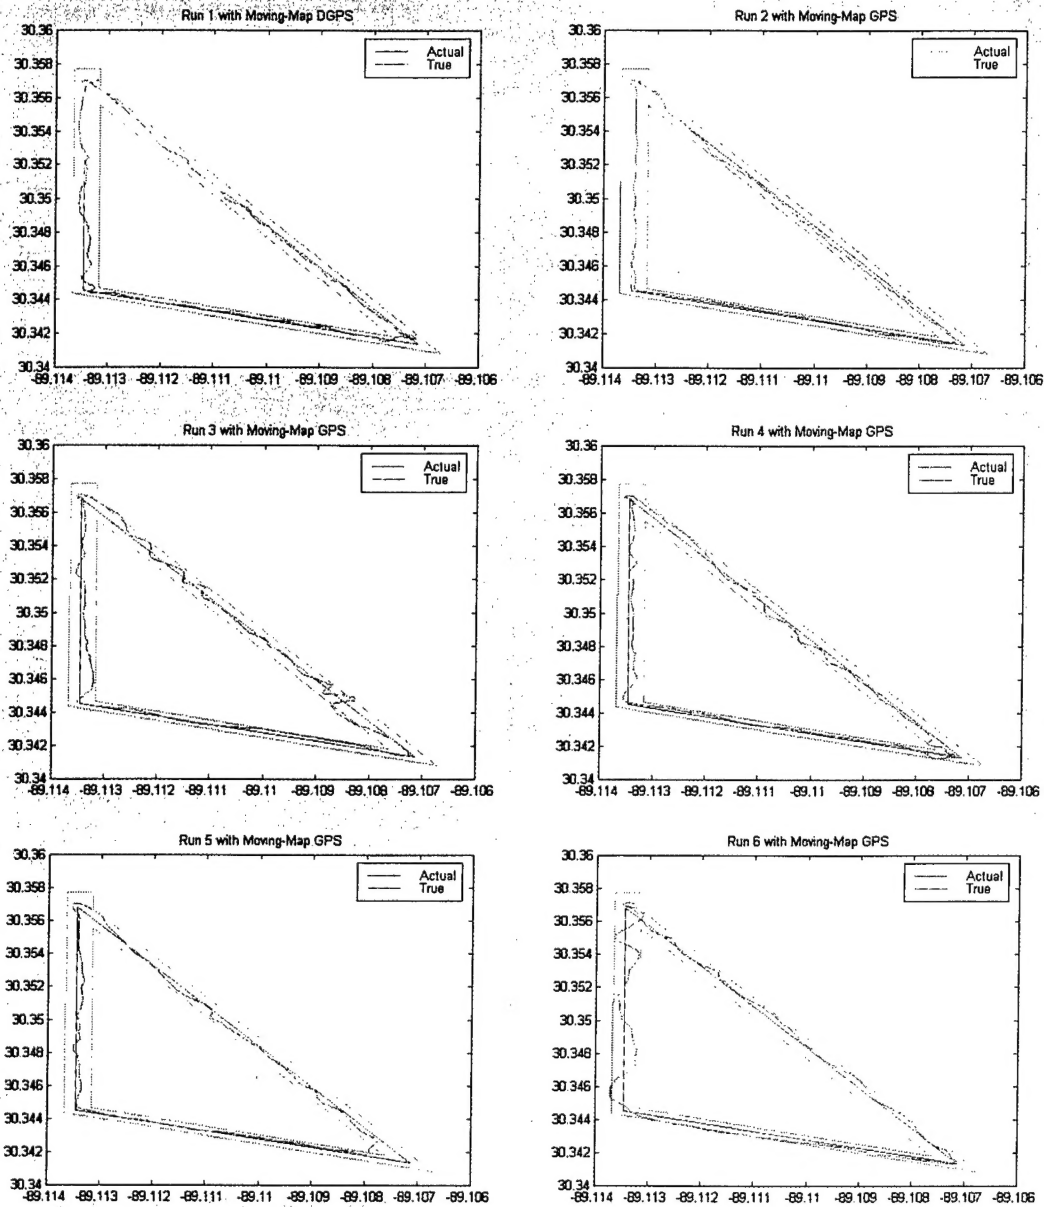
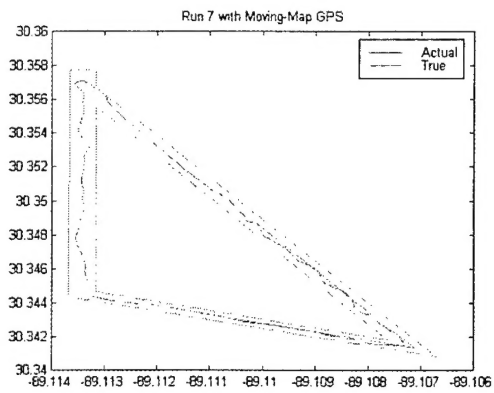
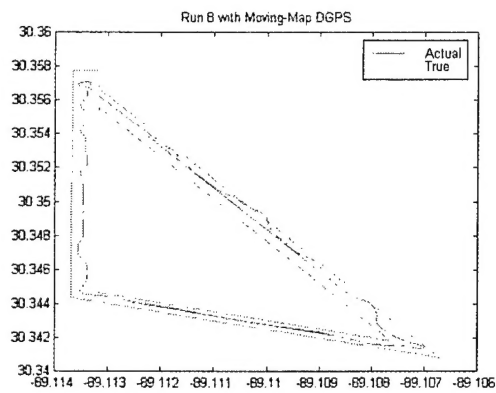
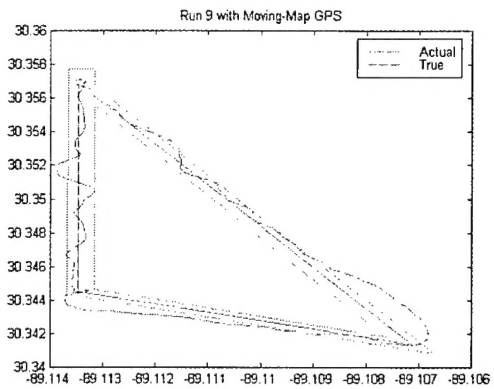
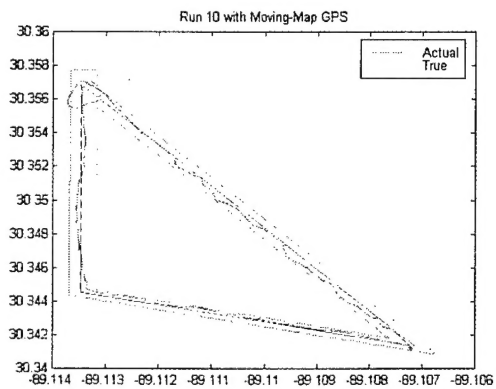
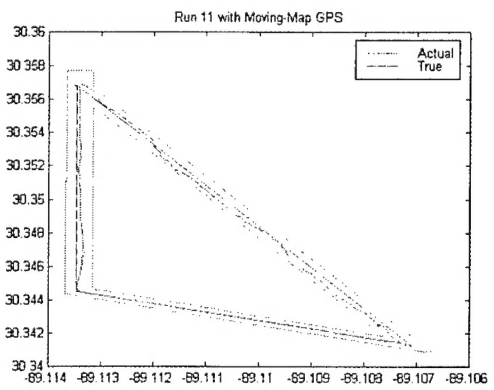
Plots showing actual versus true navigational coordinates for all test runs. Within each plot, a green line is used to outline the entire 50-yard width of navigation lane, the lane center is drawn in blue, and the AAV track is drawn in red. The beach was located in the northwest portion away from the plot
